Corrosion of Prestressing Steels

Reported by ACI Committee 222

This report reflects the current understanding of corrosion of prestressing steels in concrete. The report includes chapters that cover the various types of prestressing steel, including some discussion on metallurgical differences. Deterioration mechanisms are discussed, including hydrogen embrittlement and stress-corrosion cracking. Methods to protect prestressing steel against corrosion in new construction are presented, along with a discussion of field performance of prestressed concrete structures. Finally, field evaluation and remediation techniques are presented.

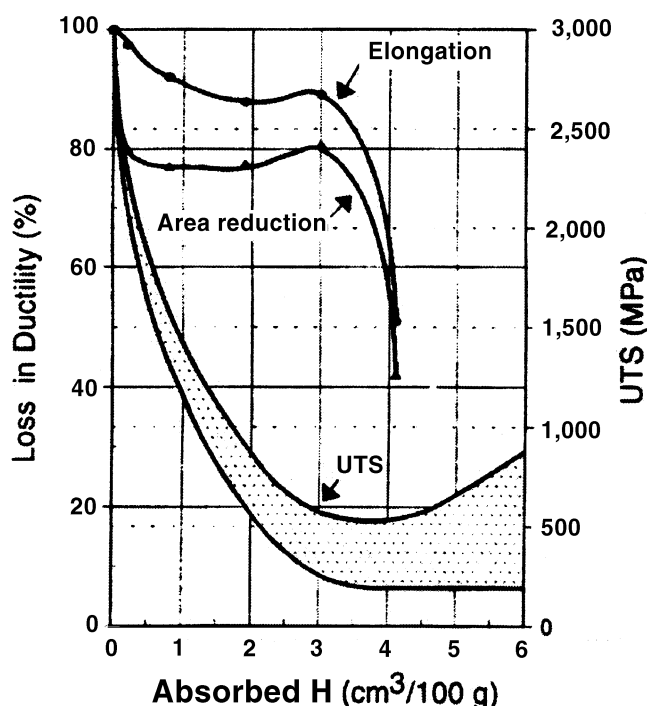
Fig. 3.5—Ductility and UTS of high-strength steel versus total H content (Klodt 1969).

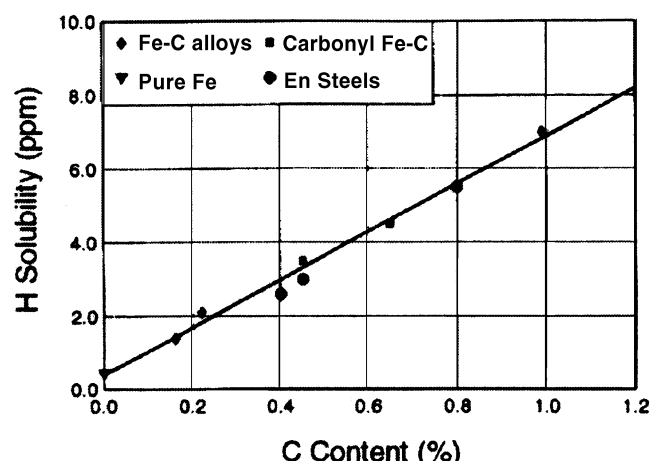
Fig. 3.6—Effect of C content on H absorption of a steel (Klodt 1969).

rite-cementite interface area (Fig. 3.6);

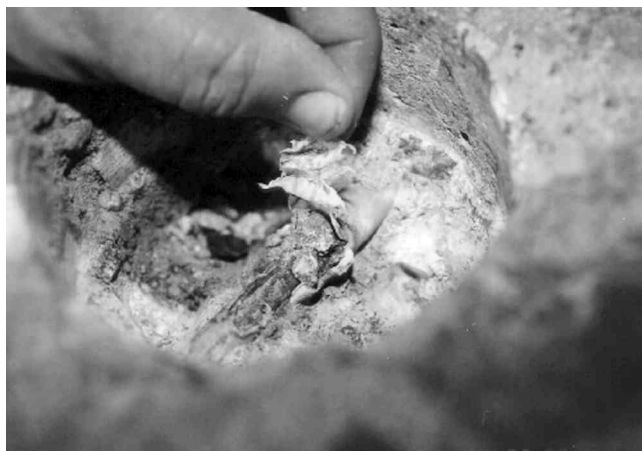
Fig. 5.2—Existing damage to tendon duct.

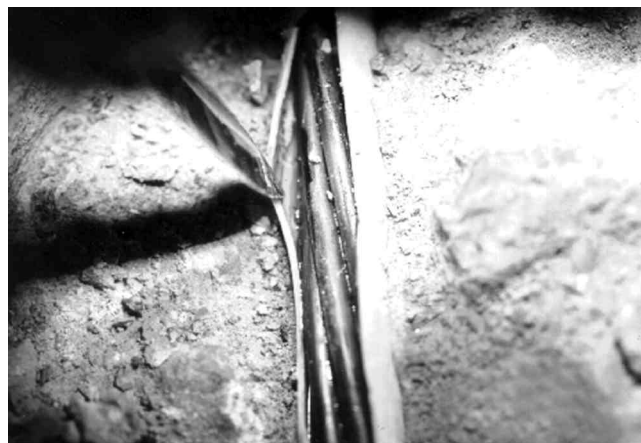
Fig. 5.3—In-place examination of an unbonded tendon.

the polyethylene sheathing demonstrated the presence of significant moisture in the sheath (at the tip of the knife blade) and an absence of significant grease.

Invasive probing—The most common evaluation method is visual inspection through invasive probing of the member. The location and cover to unbonded tendons can be determined nondestructively using a cover meter or impulse radar. Concrete can be removed to gain access to the tendons by careful chipping or coring of the concrete. Demolition should be conducted so that the tendons and ducts are not damaged. Before examining the tendon itself, the duct should be carefully examined for damage or other signs of distress. An example of existing damage to a duct is shown in Fig. 5.2. In this case, the polyethylene sheath around a monostrand tendon was damaged by a vibrator during concrete placement. Damage to the duct can be important because it gives moisture, oxygen, and chlorides easier access to the tendon. After examining the ducts, the tendons themselves should be examined by removing a portion of the duct. This should be done carefully so important information is not missed during the examination. For example, in Fig. 5.3, careful breaching of

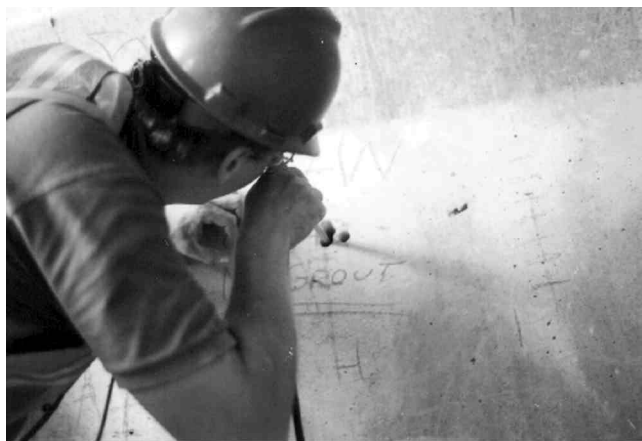
Fig. 5.6—Field examination of grouted tendon duct with invasive probing.

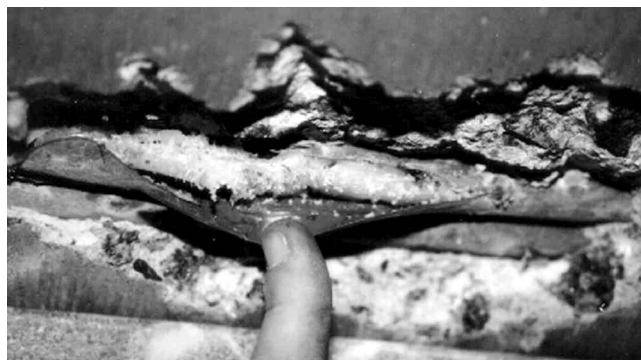
Fig. 6.2—Cured urethane grout completely encapsulating a monostrand tendon.
